# Taralga Wind Farm

Operational Environmental Impact Audit 2016

Client: Pacific Hydro Pty Ltd

05-Dec-2016

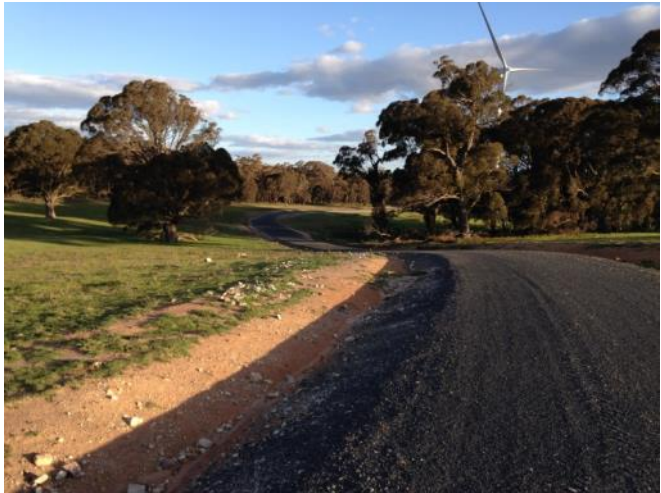
Photo #	Comment	Photo
<b>Soil and Water Management Plan</b>		
4-1.	<p>A surface water channel on the ridge line (between WTG20 and WTG31) showing limited seeding success.</p> <p>Refer to <b>2016-OFI-009</b> (Audit Ref #041)</p>

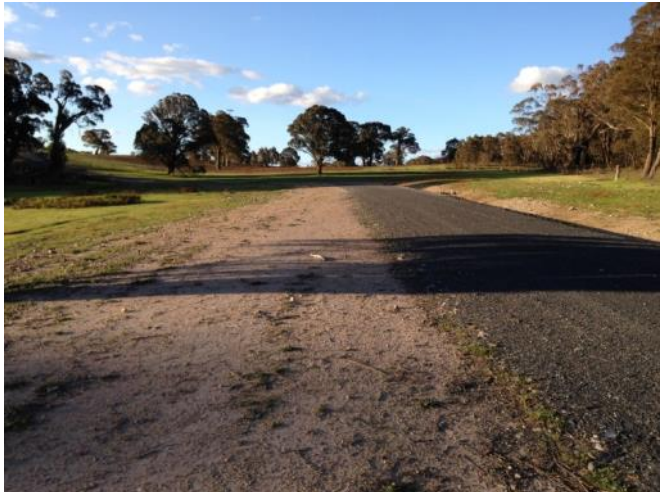
4-2.	<p>A disturbed area of land adjacent to the ridge line access road (between WTG20 and WTG31) showing limited seeding success.</p> <p>Refer to <b>2016-OFI-009</b> (Audit Ref #041)</p>

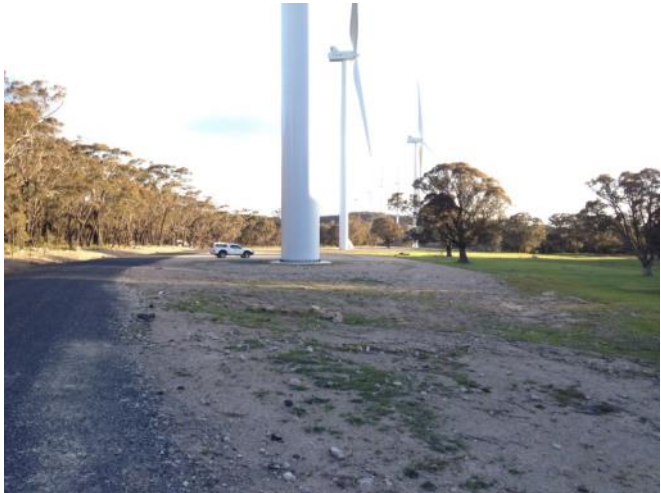
Photo #	Comment	Photo
4-3.	<p>A disturbed area of land beneath WTG30 on the ridge line showing limited seeding success.</p> <p>Refer to <b>2016-OFI-009</b> (Audit Ref #041)</p>

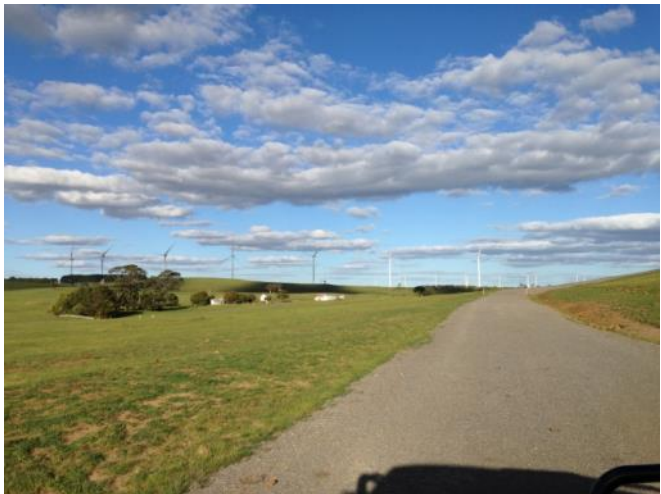
4-4.	<p>Evidence of established seeding adjacent to the access road on the lower section of the Site.</p>

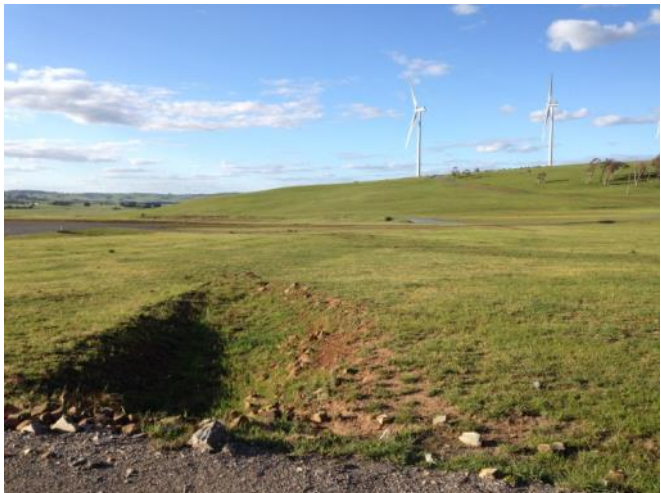
4-5.	<p>Evidence of established grass in a surface water drain in the lower section of the Site.</p>

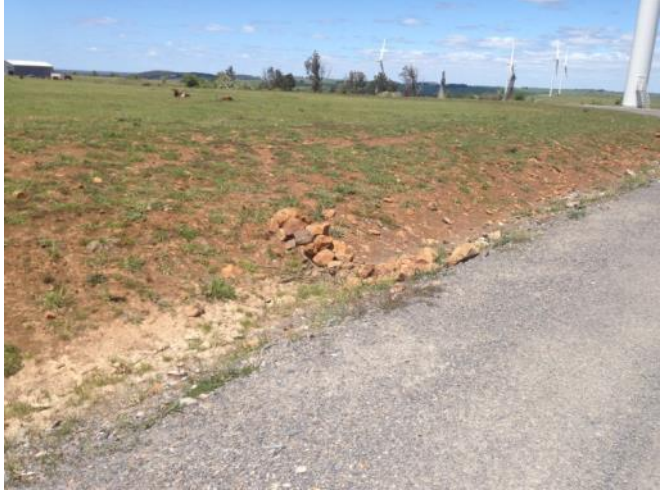
Photo #	Comment	Photo
4-6.	<p>Rock check dams in a surface water channel adjacent to an access road.</p> <p>Refer to <b>2016-OFI-12(a)</b> (Audit Ref #049)</p>

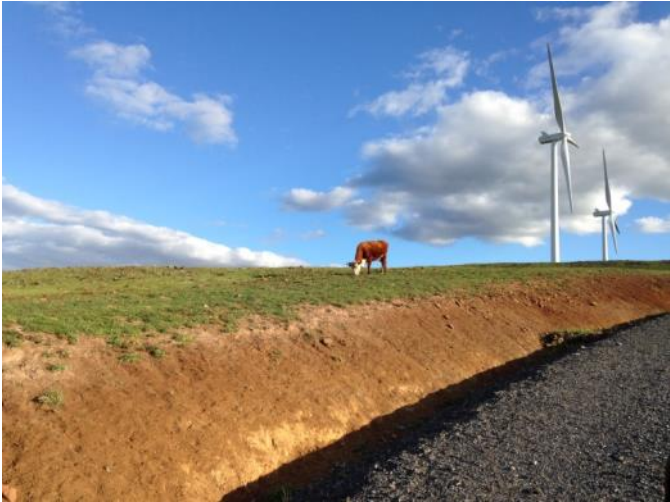
4-7.	<p>Isolated areas of disturbed land were observed adjacent to the access roads. These areas had been identified in the monthly Environmental Inspections. It is noted that some areas had been impacted by livestock reducing the potential for seeding success.</p>

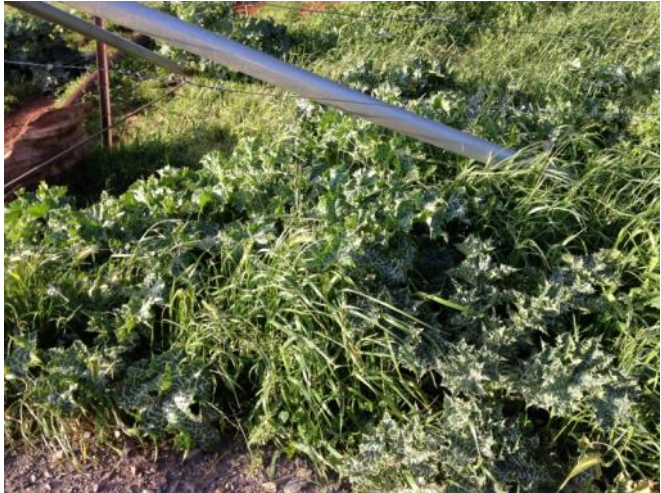
4-8.	<p>Weeds were observed on land where a landowner had requested the area not be sprayed due to a nearby crop.</p> <p>Refer to <b>2016-OFI-10</b> (Audit Ref #042).</p>

042	5.4	<p><u>Revegetation Maintenance Program</u> *^</p> <p>Monitoring of success of re-seeding. Where re-seeding fails, ongoing re-application of seed is to continue along with watering and weed spraying until such time as re-seeding is successful.</p> <p>Soil disturbance may be required to break up any hard crust that has formed or other soil amelioration used if rehabilitation is not successful.</p> <p>Site wide monitoring will be performed monthly with more regular inspection of specific areas (those underperforming and requiring additional rehabilitation work) on a more regular basis.</p> <p><b>Frequency:</b> Monthly monitoring, re-seeding as required.</p> <p><b>Management doc:</b> Environmental Site Inspection Incident Register</p>	<p>Monitoring of re-seeding success was undertaken by the Asset Manager as part of the monthly Environmental Inspections. Isolated areas of disturbed land were observed adjacent to the access roads. These areas had been identified in monthly Environmental Inspections. It is noted that some areas had been impacted by livestock reducing the potential for seeding success. Site management reported that remediation was underway for areas where reseeding had not established. The Environmental Inspection Issue Register was sighted that included references to "<i>patchy rehab, erosion in drains, sediment build up</i>". The Register notes that the Asset Manager had notified Vestas, EDI Downer to the issues and generally included observations concerning rehabilitation and sediment and erosion.</p> <p>The following Environmental Inspection records were sighted: 07/06/2016, 12/07/2016, 14/07/2016, 26/07/2016, 06/09/2016 and 09/09/2016. It is noted that the Environmental Inspection Sheet (Rev A- 26 Aug 2015) included categories for "<i>WTGs, Roads, Drains, Culverts, Erosion Control, Revegetation, Weeds, APZ, Fauna and Other</i>".</p> <p>Site management reported that Taralga Rural Pty Ltd conducted spraying of weeds. It is noted that:</p> <ul style="list-style-type: none"> <li>One landowner requested weed spraying not be conducted in the vicinity of their crop; and</li> <li>One landowner requested the Site supply the weed spray and that the landowner conduct the spraying themselves.</li> </ul> <p>Site management reported that they agreed to both requests. Weeds were observed on land where a landowner had requested the area not be sprayed due to a nearby crop.</p>	Compliant	<p><b>2016-OFI-10</b></p> <p>An alternative control to spraying should be considered and implemented for weed management on land adjacent to landowner's crops.</p>

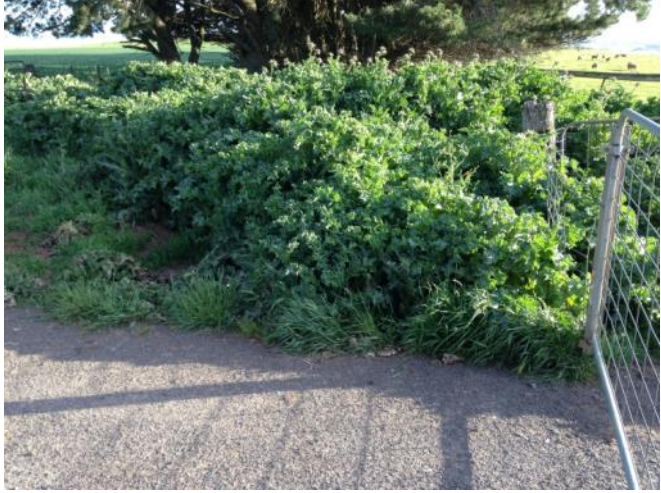
Photo #	Comment	Photo
4-9.	<p>Weeds were observed on land where a landowner had requested the area not be sprayed due to a nearby crop.</p> <p>Refer to <b>2016-OFI-10</b> (Audit Ref #042).</p>

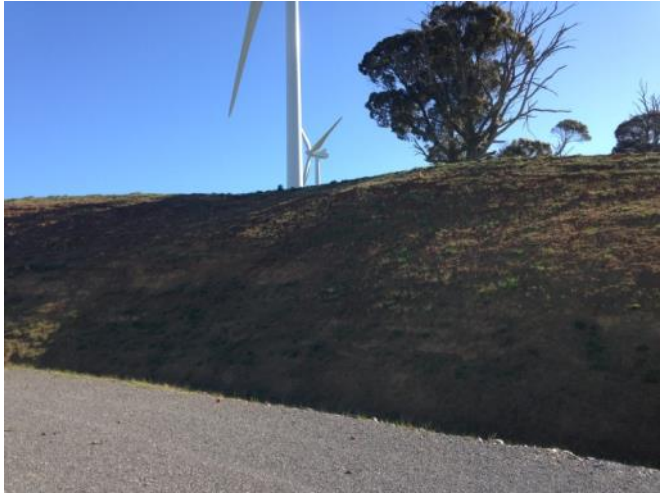
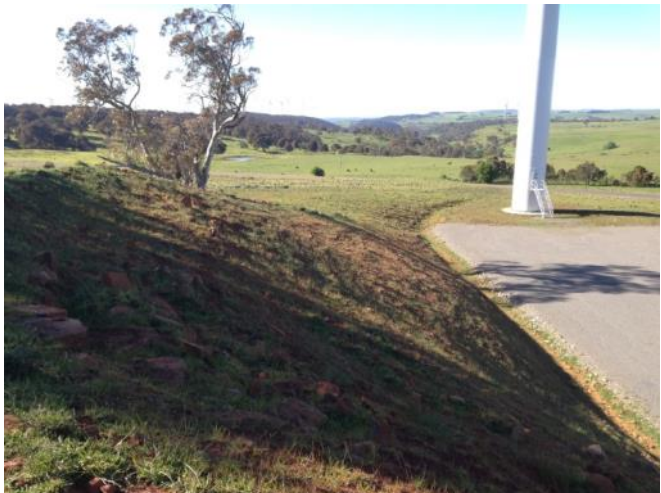
4-10.	<p>At the time of the Site inspection rehabilitation to the WTG49 embankment was not established and the area was not fenced off to protect against livestock. Evidence of livestock hoof marks was observed on the embankment during the Site inspection.</p> <p>Refer to <b>2016-OFI-11</b> (Audit Ref #043).</p>

Audit Ref #	OEMP Ref	Requirement	Comments / Evidence Sighted / Key Findings	Compliance Status	Opportunity for Improvement
043	5.4	<p><u>Fencing off of Rehabilitation Areas</u> *^</p> <p>On-site high erosion hazards areas will be fenced off from livestock. These areas will include the:</p> <ul style="list-style-type: none"> <li>• eastern end of the T58 hardstand; and</li> <li>• northern side of the T49 hardstand.</li> </ul> <p>Other areas may be identified as construction is completed. High risk areas are shown in Drawings EV05 to EV07 in Appendix F.</p> <p><b>Frequency:</b> As required.</p> <p><b>Management doc:</b> Environmental Site Inspection</p>	<p>Site management reported that the location of WTG49 had to be moved due to an identified heritage zone. This resulted in a steeper embankment to the north of the work pad that required seeding. At the time of the Site inspection rehabilitation to the WTG49 embankment was not established and the area was not fenced off to protect against livestock. Evidence of livestock hoof marks was observed on the embankment during the Site inspection. The Environmental Inspection Issue Register included references to "poor rehab" and "It appears that grass seed washed away from steeper areas leading to erosion and sediment build up". The Register notes that the Asset Manager had notified Vestas, EDI Downer to the issues. Revegetation at WTG58 was considered to be satisfactory at the time of the Site inspection and no fencing was required.</p> <p>The following Environmental Inspection records were sighted: 07/06/2016, 12/07/2016, 14/07/2016, 26/07/2016, 06/09/2016 and 09/09/2016.</p> <p>Site management reported that there were no other areas on-site that required fencing to protect against livestock and none were observed by the auditors.</p> <p>On the basis that the high erosion hazard area at WTG49 had not been fenced off, this requirement has been assessed as non-compliant. The potential for environmental consequences was considered low due to the low sensitivity of the receiving environment for sediment (cattle paddock with no surface water drains in the vicinity).</p>	<p><b>Non-compliant</b></p> <p><b>Low Risk</b></p>	<p><b>2016-OFI-11</b></p> <p>The embankment to the north of WTG49 should be re-seeded and fenced to protect against livestock. Monitor and manage the progress of re-seeding on a regular basis until the vegetation is self-sustaining and it meets the requirements of the landowner.</p>

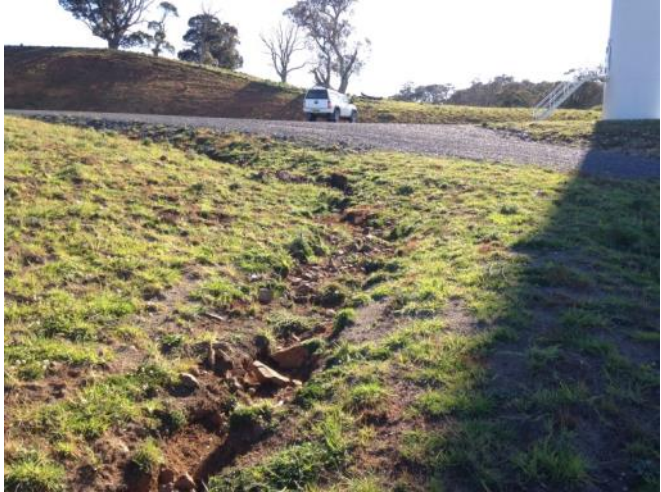
Photo #	Comment	Photo
4-11.	<p>Evidence of erosion on the run-off area adjacent to WTG49.</p> <p>Refer to <b>2016-OFI-12(b)</b>, <b>2016-OFI-12(c)</b> and <b>2016-OFI-12(d)</b>, (Audit Ref #049).</p>

Audit Ref #	OEMP Ref	Requirement	Comments / Evidence Sighted / Key Findings	Compliance Status	Opportunity for Improvement
049	5.4	<p><u>Maintenance of Erosion and Sediment Control</u></p> <p>Inspection of erosion and sediment control measures on a monthly basis and after significant rainfall (more than 15mm in one hour or more than 30mm over 24 hours).</p> <p>Repairs to be undertaken as required, including cleaning out of barriers and removal of sediment. Repairs may also include barrier replacement, or additional measures where soil disturbance has occurred due to maintenance activities or erosion risk is identified.</p> <p>Design drawings of barriers to be used are provided in Appendix F. Rock check banks (Drawing SD5-4) were found to be most effective barrier during construction while straw bales (Drawing SD6-7) were also used for short term measures if not located in stocked paddocks.</p> <p>The maximum spacing of barriers is given in Drawings EV05 to EV07 in Appendix F.</p> <p>Sediment basins at the Service Compound and at significant drainage line crossings will be maintained for the life of the Wind Farm. Other temporary sediment basins (at crane hardstands and access tracks) and erosion control barriers will be removed only after rehabilitation works have been completed on more than 90% of the contributing catchment.</p>	<p>The following Environmental Inspection records were sighted: 07/06/2016, 12/07/2016, 14/07/2016, 26/07/2016, 06/09/2016 and 09/09/2016. The Environmental Inspection Issue Register was noted to include erosion and sediment issues for specific locations across the Site. The Register noted that the responsibility of the identified erosion issues was with EPC and their contractor. The Asset Manager was responsible for the management of rock check dams and culverts.</p> <p>Monthly Environmental Inspections note if an inspection was conducted after a rain event. Sighted an inspection form dated 14 July 2016 following a rain event.</p> <p>Site management reported that they had commissioned Divall's Earthmoving and Bulk Haulage Pty Ltd to clean out the surface water drain at the Ainsworth Crossing and replace rock where necessary.</p> <p>The sediment basin and associated drains were observed at the compound during the Site inspection. Site management reported that some landholders had requested that sediment basins used during construction activities remain so that they could be used for watering their livestock.</p> <p>Grass was observed to be established in sediment in some surface water drains on the lower section of the Site. Site management reported that the decision had been made to leave the grassed sediment in place rather than remove it and expose bare soil which may lead to future sediment issues. The auditors concur with Site management's process to leave established grass in surface water channels where sediment may have accumulated; however, the source of the sediment should be determined, adequacy of remaining capacity assessed and measures taken to prevent further accumulation.</p>	<b>Non-compliant Medium Risk</b>	<p><b>2016-OFI-12a</b></p> <p>The source of sediment in drainage channels within the lower section of the site should be investigated and measures taken to prevent further accumulation. Consideration should be given to increasing the water-holding capacity of rock check dams where grassed sediment has accumulated.</p> <p><b>2016-OFI-12b</b></p> <p>The layout, design and spacing of interception structures of the surface water drains/culverts around WTG49 should be assessed to ensure it complies with the Landcom, 2004 publication, <i>Managing Urban Stormwater: Soils and Construction</i> (Blue Book).</p> <p><b>2016-OFI-12c</b></p> <p>Vegetation cover should be established on the sill surface water runoff area on the landholders land adjacent to WTG49 and the area should be fenced to exclude livestock if grazing or tracking is likely to impact re-vegetation.</p>

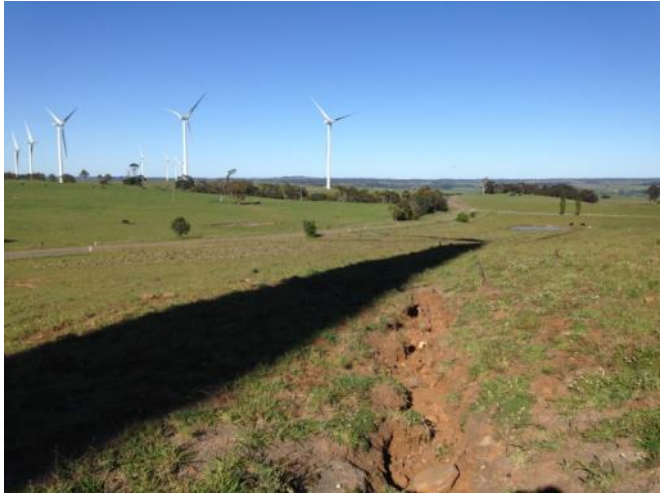
4-12.	<p>Evidence of erosion on the run-off area adjacent to WTG49.</p> <p>Refer to <b>2016-OFI-12(b)</b>, <b>2016-OFI-12(c)</b> and <b>2016-OFI-12(d)</b>, (Audit Ref #049).</p>

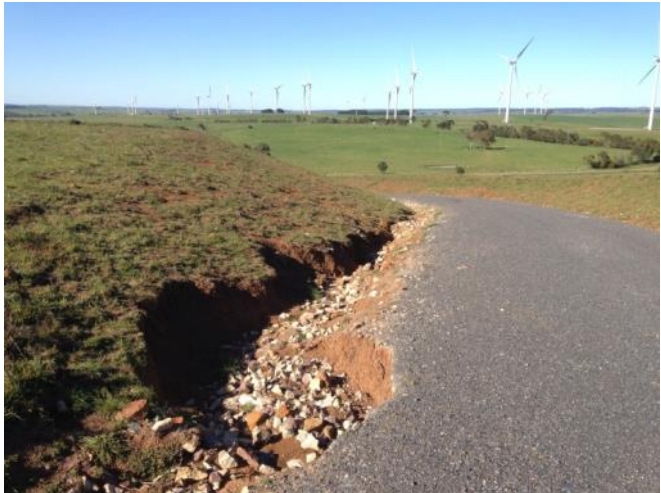
4-13.	<p>Evidence of erosion in the surface water drains/culverts adjacent to the WTG49 access road.</p> <p>Refer to <b>2016-OFI-12(b)</b>, <b>2016-OFI-12(c)</b> and <b>2016-OFI-12(d)</b>, (Audit Ref #049).</p>

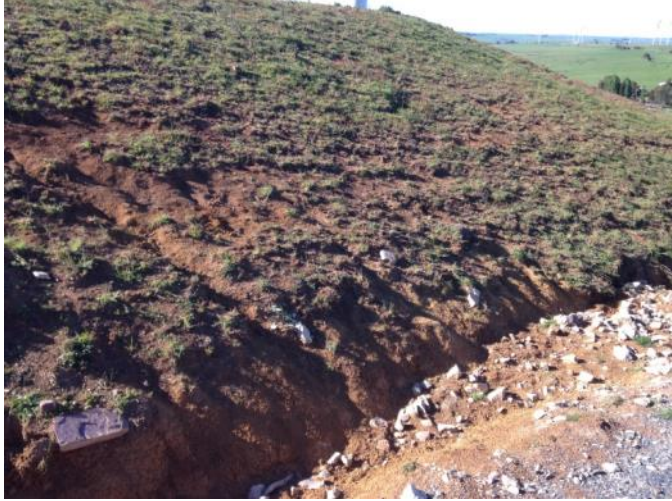
Photo #	Comment	Photo
4-14.	<p>Evidence of erosion in the surface water drains/culverts adjacent to the WTG49 access road.</p> <p>Refer to <b>2016-OFI-12(b)</b>, <b>2016-OFI-12(c)</b> and <b>2016-OFI-12(d)</b>, (Audit Ref #049).</p>

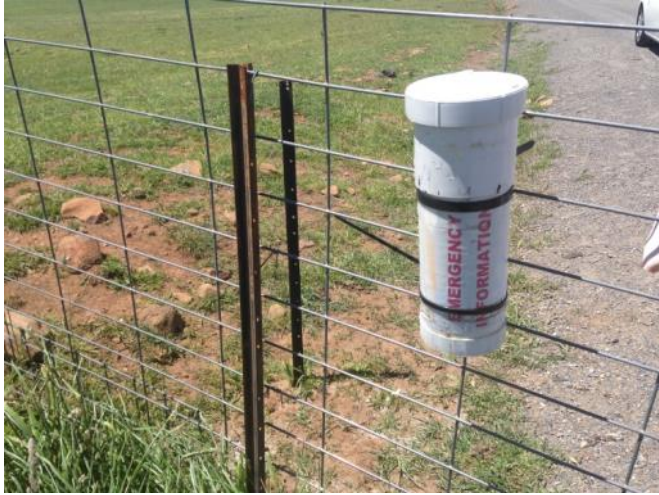
4-15.	<p>Emergency information was observed to be available in canisters at each Site entrance. The auditors observed canisters at EP2, EP3, EP4 and EP5. Maximum quantities of hazardous substances and dangerous goods omitted from canister information.</p> <p>Refer to <b>2016-OFI-13</b> (Audit Ref #055).</p>

055	5.4	<p><u>Identification of Hazardous Materials</u></p> <p>Maintenance of a Hazardous Substances and Dangerous Goods Yellow Folder in the Service Compound which includes:</p> <ul style="list-style-type: none"> <li>Material Safety Data Sheets (MSDS) for all chemical substances brought onto Site;</li> <li>Site Map showing the location of hazardous materials;</li> <li>Allowable storage quantities; and</li> <li>A list of Personnel approved to access the hazardous materials.</li> </ul> <p><b>Frequency:</b> Ongoing</p> <p><b>Management Doc:</b> Hazardous Substances and Dangerous Goods Yellow Folder; MSDS</p>	<p>Safety Data Sheets (SDS) were observed to be stored in a folder in the Site Office.</p> <p>Emergency information capsules located at each entrance to the Site as well as the Site Compound were observed to include maps showing the location of hazardous materials but not maximum quantities. A list of personnel approved to access the hazardous materials was not available.</p> <p>Two hazardous materials cabinets in the Workshop as well as the two dangerous goods containers in the Service Compound displayed the maximum storage quantities.</p>	<b>Administrative Non-compliance</b>	<p><b>2016-OFI-13</b></p> <p>The maximum allowable storage quantities for Hazardous Substances and Dangerous Goods as well as a list of personnel approved to access the hazardous materials should be included in the SDS folder and emergency capsules.</p>

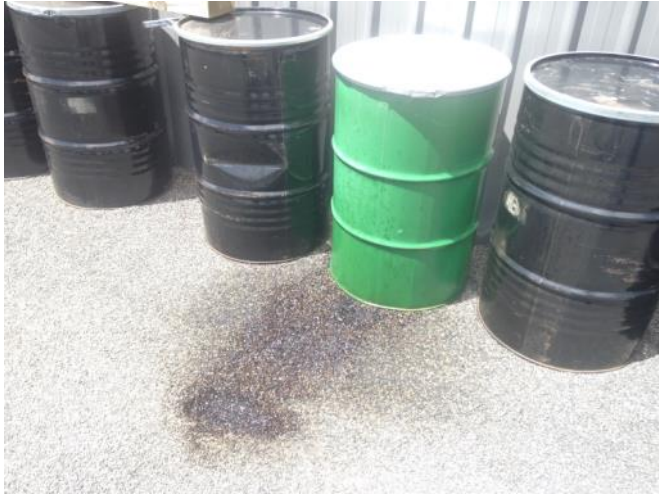
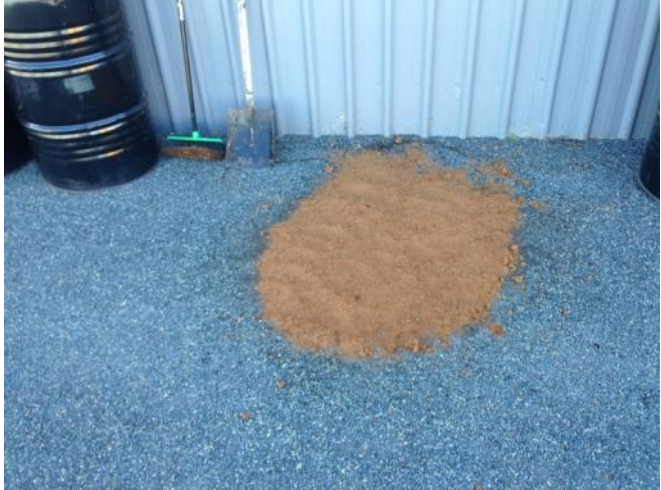
4-16.	<p>The Auditors observed a leaking 200 L drum at the time of the Site inspection. Site management reported that the leak had been noticed a few weeks prior to the Site inspection and that secondary containment equipment had been purchased; however, the leak had not been cleaned-up or recorded in the Incident Register.</p> <p>The leaking drum was moved to one of the bunded chemical storage containers during the Site inspection and sand was placed over the impacted gravel.</p>

Photo #	Comment	Photo
	Refer to <b>2016-OFI-14(a)</b> and <b>2016-OFI-14(b)</b> (Audit Ref #056).

Audit Ref #	OEMP Ref	Requirement	Comments / Evidence Sighted / Key Findings	Compliance Status	Opportunity for Improvement
056	5.4	<p><u>Storage of Hazardous Materials</u></p> <p>All hazardous materials will be stored in Australian Standard storage containers according to AS 1940-2004 and in accordance with Storing and Handling liquids: Environment Protection, Participants Manual: Appendix: Technical Considerations (DECC, 2007).</p> <p>Wastes may accumulate in small quantities at the point of generation. Wastes are typically accumulated in 200 L (55-gallon) drums or purpose designed waste containers that are stored within a secondary containment.</p> <p>As waste containers are filled, they will be moved to designated hazardous waste storage areas. The chemical and hazardous waste storage areas are inspected every six months to prevent releases, explosions, and fires.</p> <p><b>Frequency:</b> Ongoing</p> <p><b>Management Doc:</b> Hazardous Substances and Dangerous Goods Yellow Folder; Materials Safety Data Sheets (MSDS)</p>	<p>Two hazardous materials cabinets were located in the Workshop. The cabinets each displayed a maximum capacity of 250 Litres (L).</p> <p>Two dangerous goods containers with built in secondary containment were located in the Service Compound and displayed a maximum storage capacity of 1,500 L each (supplied by Tradecorp International Pty Ltd). Signage on the containers indicated that they complied with the requirements of AS 1940-2004. An assessment against the requirements of AS 1940-2004 was not included in the scope of works for the audit and was not conducted by the auditors.</p> <p>A double skinned above ground waste oil storage tank with a capacity of 4,000 L was located in the Service Compound.</p> <p>The back-up generator located in the Service Compound was reported to have a double skinned diesel storage tank (unknown capacity). The generator was not accessed during the Site inspection due to health and safety requirements.</p> <p>Twelve 200 Litre (L) steel drums were observed to be stored adjacent to the Workshop. Site management reported the drums are used to store oily rags, empty grease containers and other waste hydrocarbon material related to maintenance activities on the WTGs (i.e. on-site away from the Site Compound). The drums were stored on the gravel hard stand of the Site Compound without secondary containment (i.e. bunded pallet). The auditors observed a leaking 200 L drum at the time of the Site inspection. Site management reported that the leak had been noticed a few weeks prior to the Site inspection and that secondary containment equipment had been purchased; however, the leak had not been cleaned-up or recorded in the Incident Register. Site management reported that the leak occurred as the internal plastic bag had not been fully sealed. The leaking drum was moved to one of the bunded chemical storage containers during the Site inspection and sand was placed over the impacted gravel.</p>	<p><b>Non-compliant</b></p> <p><b>Low Risk</b></p>	<p><b>2016-OFI-14a</b></p> <p>Drums containing controlled wastes (i.e. oily rags) should be stored with secondary containment in a dedicated storage area.</p> <p><b>2016-OFI-14b</b></p> <p>Ensure that the plastic bags that are placed into the 200 L steel drums to store hazardous materials are fully sealed before sealing the drum.</p>

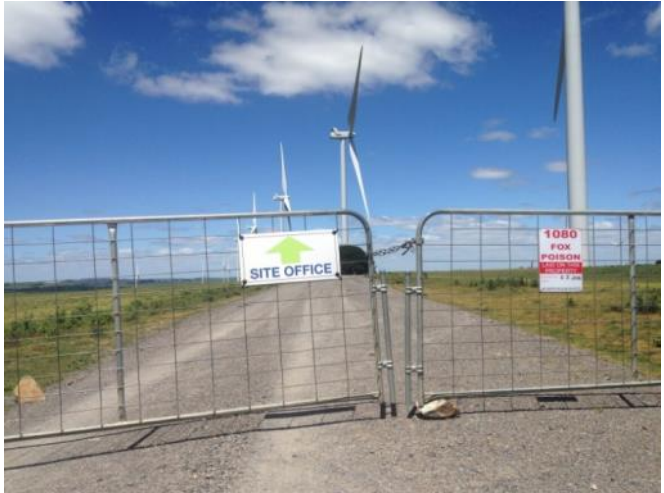
4-17.	<p>Access to Landholders properties was via manually operated gates.</p> <p>Site management reported that there are plans to install cattle grids and automated gates to facilitate the ease of passage for Site personnel and to manage potential health and safety issues in strong winds.</p>

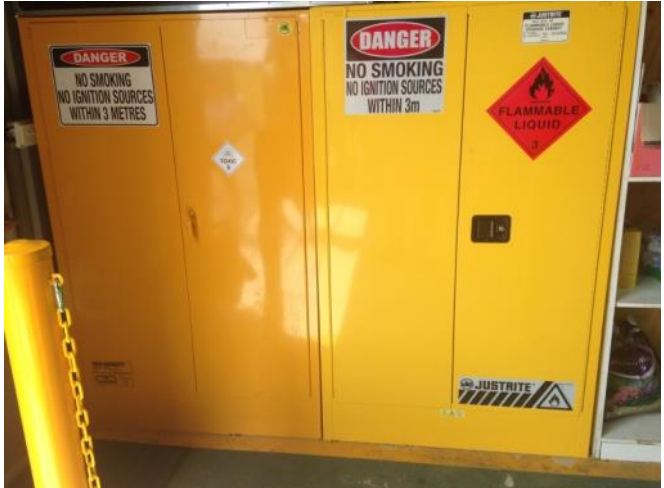
4-18.	Two hazardous materials cabinets were observed in the Workshop.

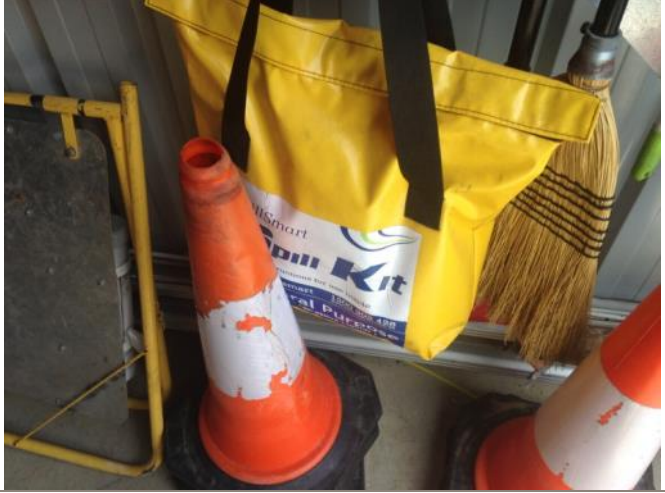
Photo #	Comment	Photo
4-19.	A spill kit was observed in the Workshop. Spill kits for service vehicles had been ordered and arrived on day of Site inspection.

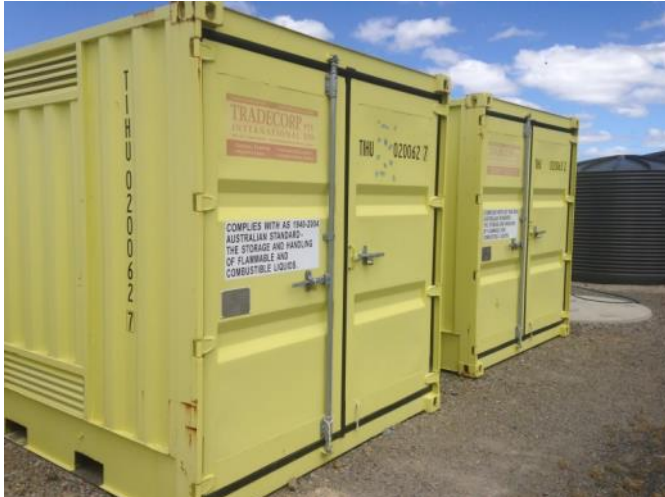
4-20.	Two dangerous goods containers with in-built secondary containment were located in the Service Compound.
