Operational Environmental Impact Report

Taralga Wind Farm

18-Mar-2020

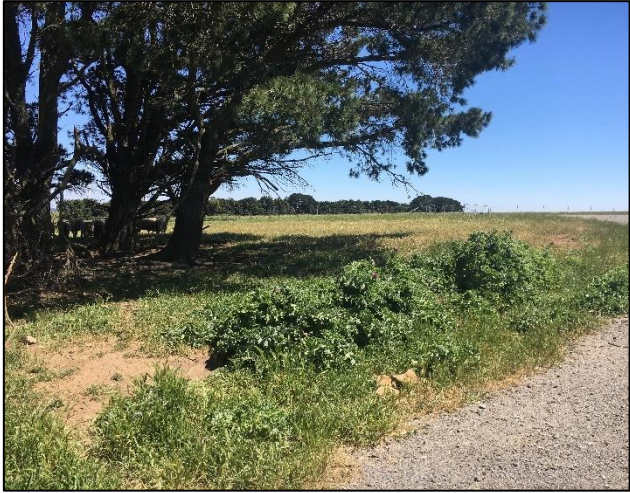
Photo #	Comment	Photo
4-1.	Examples of clusters of weeds observed in areas of the site.

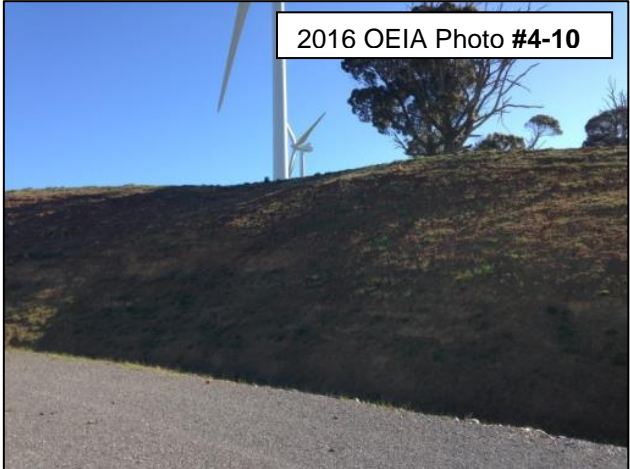
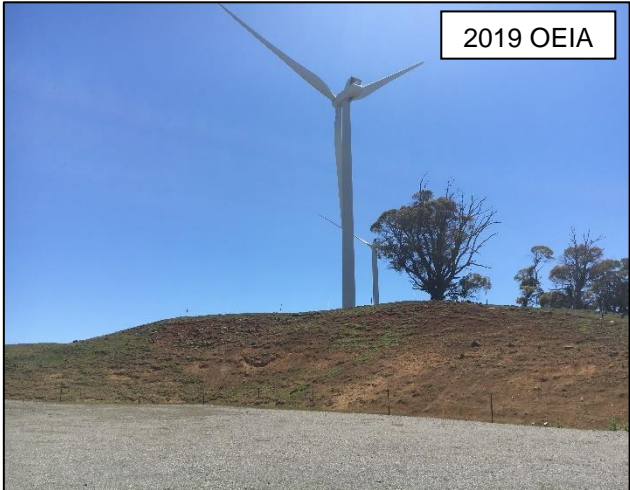
4-2.	<p>Little change was observed at the rehabilitation area located on the WTG49 embankment.</p> <p>For comparison a photo of the WTG49 embankment in 2016 has been provided (top picture). The picture below is from the 2019 OEIA Site Inspection.</p> <p>It was reported that during the period since the previous audit, attempts had been made to rehabilitate this area, including installing a temporary fence. However these had not been successful. The temporary fence was observed to have been broken in sections allowing stock access to the area.</p> <p>It was reported that a contractor has been engaged to install a permanent fence and hydro-mulch the embankment.</p> <p>2019 OEIA OFI 01 – Continue to monitor success of rehabilitation efforts at Turbine 49. Consider obtaining specialist input should attempts to hydro mulch fail to establish.</p>

2016-OFI-12d The erosion of surface water drains/culverts and the surface water runoff area at WTG49 should be logged as an incident in the Vestas IDB system and formally tracked until the issue has been closed.	<p>The erosion at Turbine 49 had not been logged as an incident but was being monitored during Quarterly Inspections and actions raised as work orders in FIXD.</p> <p>The erosion of the drains along the access road near Turbine 31 where silt was observed offsite onto neighbouring land was logged as an incident in Pacific Hydro's management system 'Intelix' on the 9 July 2019 and corrective actions taken formally tracked. This included engaging a contractor to install new rockliner in the drain. The incident was closed on the 30 October 2019, when a site visit confirmed the erosion control had been installed and photographic evidence collected.</p> <p>The Intelix system has been in place since early August 2017. Intelix allows for environmental incidents specifically 'erosion' related incidents to be logged and tracked. Intelix includes sections for recording incident details, reporting investigations, assigning corrective actions, approvals and incident closure reports. Intelix also allows for task tracking and escalation with notifications sent to the responsible personnel.</p>

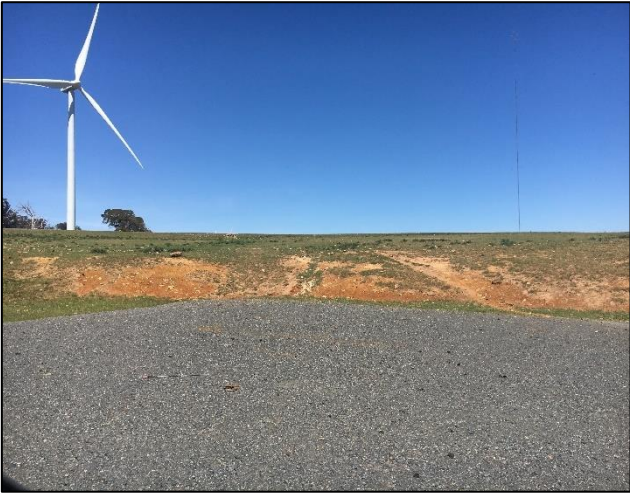
Photo #	Comment	Photo
4-3.	Example of erosion observed on banks where rehabilitation success had been impacted by stock

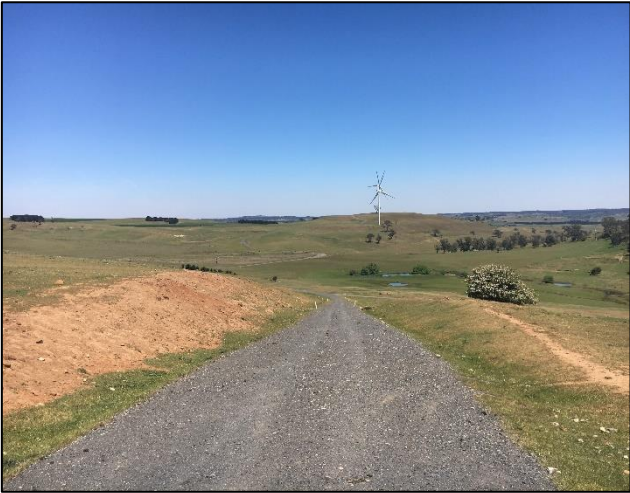
4-4.	Example of erosion (and a risk of sedimentation runoff during rainfall) due to the exposed areas on the embankment on the downhill approach to Turbine Access Road (TAR) 56/58 (photo) from TAR-52/54 (behind observer).

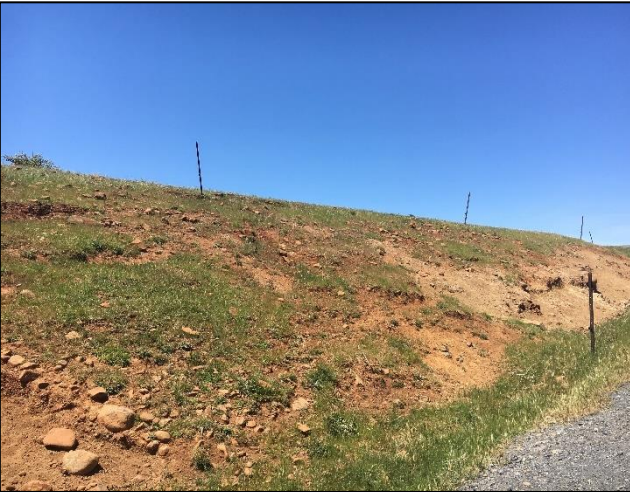
4-5.	Evidence of erosion on site. A temporary fence had been put in place by TWF to prevent stock from accessing this area. The fence had been destroyed at the time of the audit allowing stock access the embankment situated on the eastern side of the track midway between TAR - 52/54/56/58 and Bannaby Road.

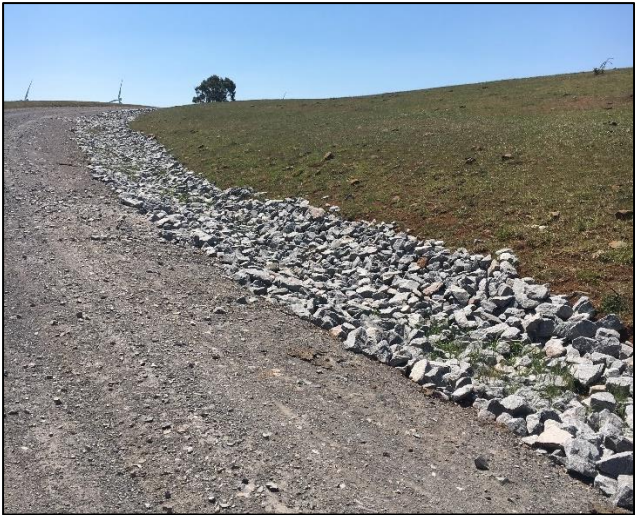
4-8.	Drainage channels have been rock lined along steep access roads to improve ground stabilisation and prevent stock from accessing the area as per this photo situated between TAR-09/10 and TAR05/06/07/08.

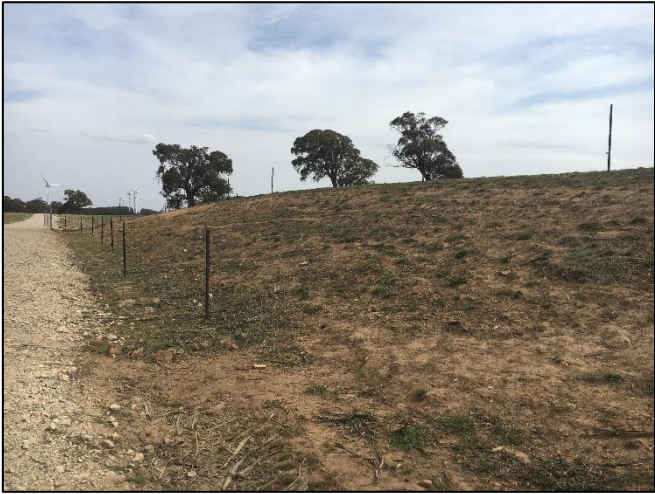
Photo #	Comment	Photo
4-9.	Area where temporary fence had been installed to prevent stock access and improve rehabilitation success (east side of track on approach to TAR-31)

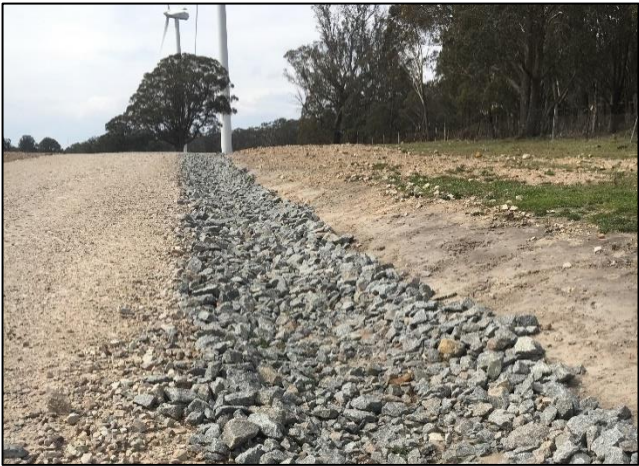
4-10.	In some areas drainage channels have been rock lined to improve ground stabilisation and prevent stock from accessing the area.

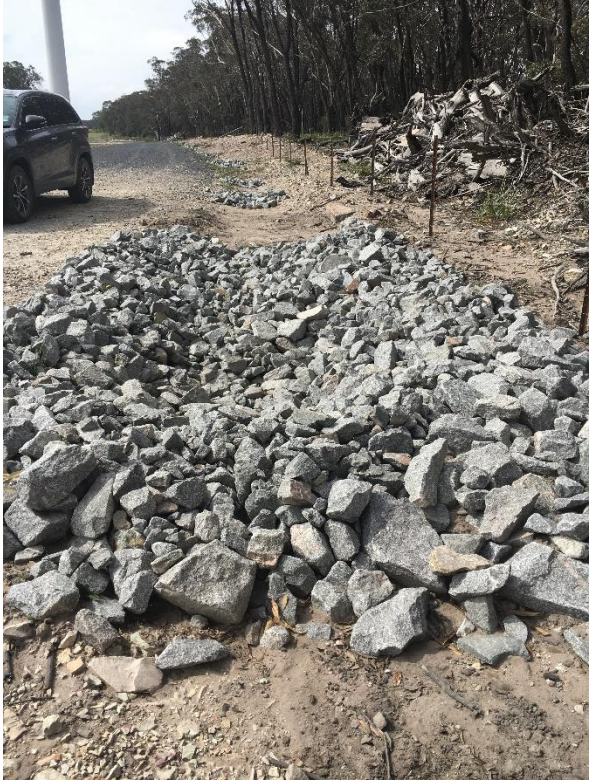
Photo #	Comment	Photo
4-12.	Rock check dams installed along access road in area near T31 where incident was recorded in July 2019 of sediment / silt being transported off-site.

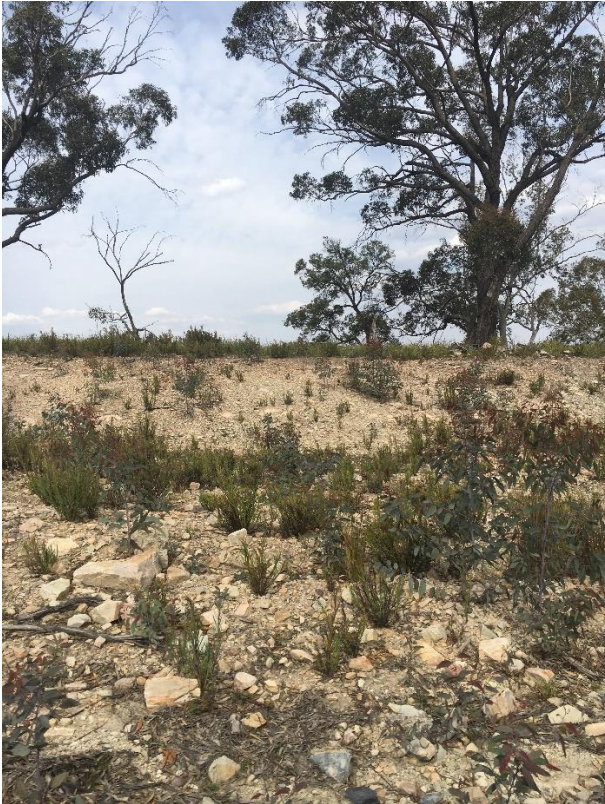
4-13.	Example of natural revegetation of disturbed area from surrounding bushland in area near T26. It is noted this section of the TWF is noted farmed and therefore not impacted by stock.

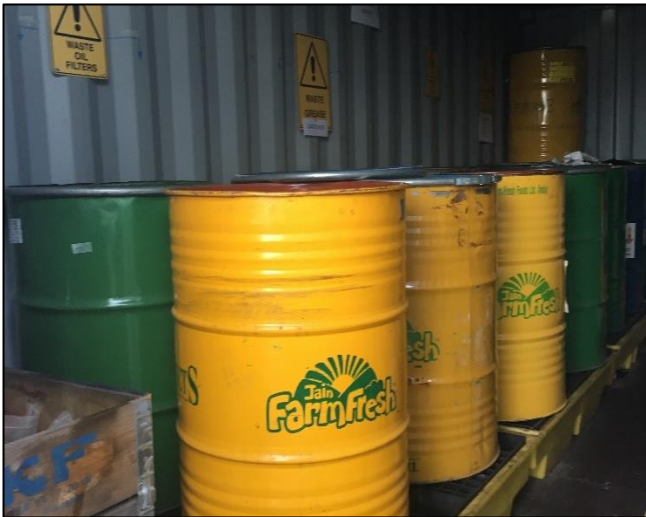
4-17.	Oily rags stored in drums on bunded pallets

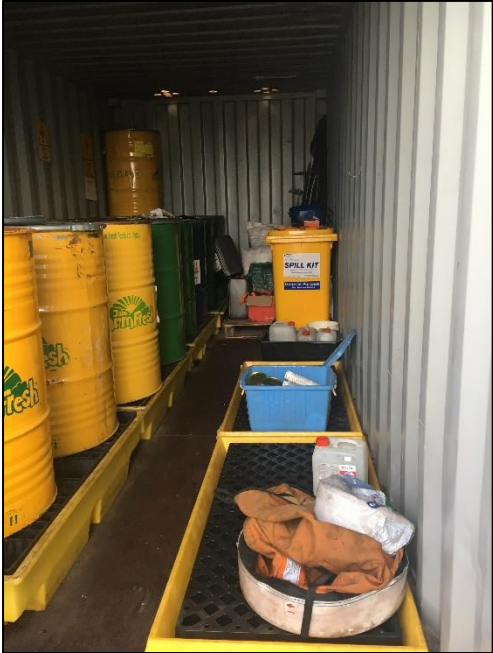
Photo #	Comment	Photo
4-18.	Waste oil rags and filters stored on bunded pallets within a container.

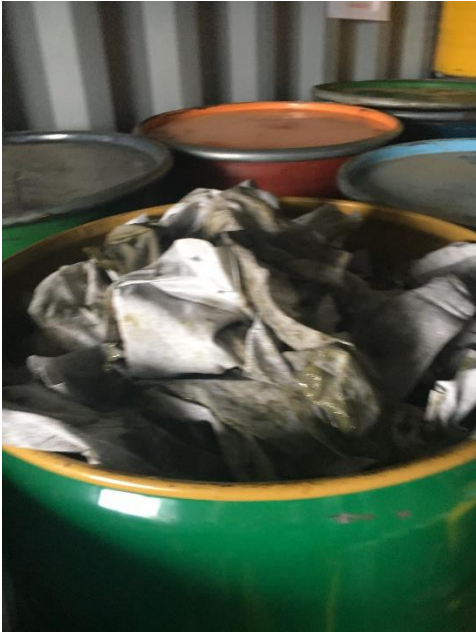
4-19.	Oily rags stored in drums on bunded pallets within storage container

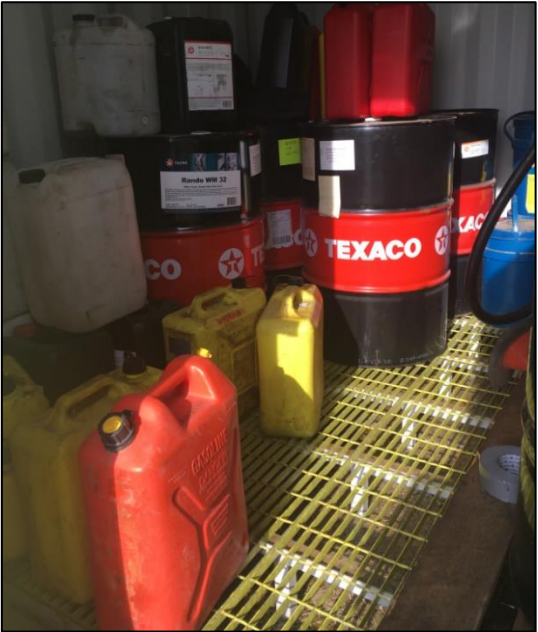
Photo #	Comment	Photo
4-20.	Oil and fuel stored on banded pallets inside a storage container.

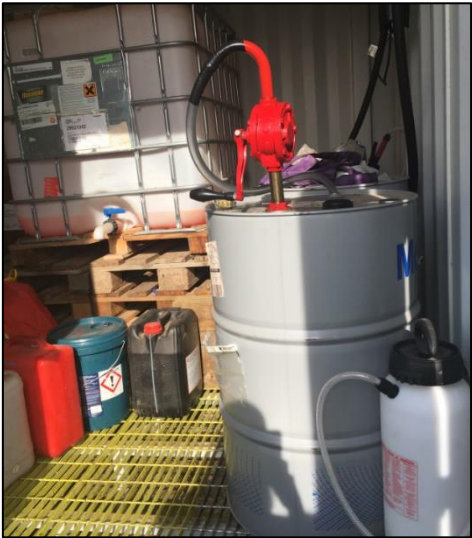
4-21.	Oil and fuel stored in a banded container.

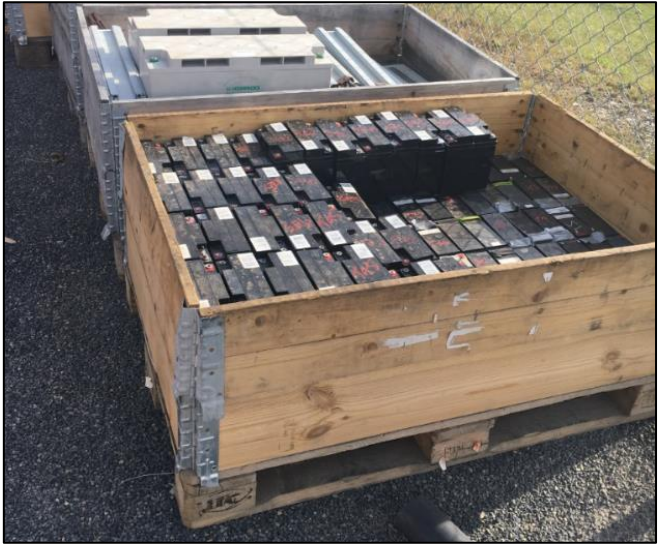
Photo #	Comment	Photo
4-24.	Waste batteries stored outside on wooden pallet in the service compound. Refer 2019 OEIA OFI 14

Recommendation	2019 Findings
	2019 OEIA REC 06 – <i>Improve storage of waste batteries by considering storing the waste batteries under cover with adequate spill containment in place.</i>
2016-OFI-21 Confirm if the waste contractor is licensed to dispose of waste generated at the Site (i.e. general waste).	Waste contractor used on site was Cleanaway. Tutt Bryant waste receptacles also sighted on site.
2016-OFI-22 Consideration should be given to removing the requirement relating to restricting lambing to paddocks within 500m of a turbine from next revision of BBAMP	<p>It was reported that discussions have been held with landowners however Pacific Hydro is restricted with how much it can influence farmers actions / enforce lambing >500m of turbines. It is also noted that for some landowners their boundaries are within 500m of a turbine and therefore they are unable to conduct lambing in excess of 500m from a turbine.</p> <p>The 2016 OEIA report provided an OFI to discuss amendment of the BBAMP with BL&A to determine the best course of action and to discuss and agree with OEH a course of action. Pacific Hydro committed to amending this commitment in the BBAMP, in its Action Plan dated 31 August 2017.</p> <p>The revised BBAMP states that the TWF should continue to minimise the potential attractiveness of the site to Wedge-tailed eagles which would include:</p> <p><i>“during lambing season (usually late autumn / early winter) working with landholders to minimise lambing within 500 metres of turbines and during lambing season monitor any instances of lambing in paddocks within 200 metres of turbines.”</i></p>

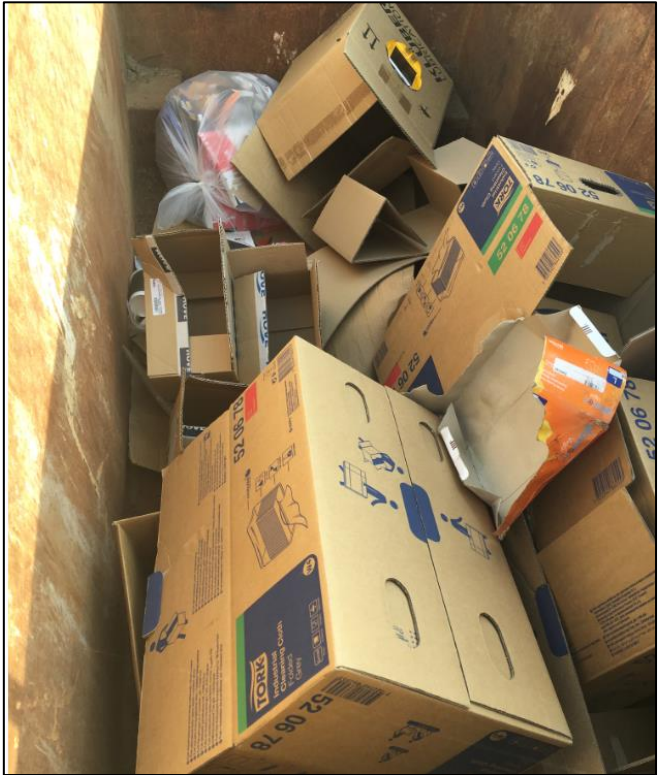
4-25.	Cross contamination of general waste with recyclables. Refer 2019 OEIA REC 08
