**CWP Renewables**

**Taralga Wind Farm  
Construction Environmental  
Impact Audit Report**

*Final Report*

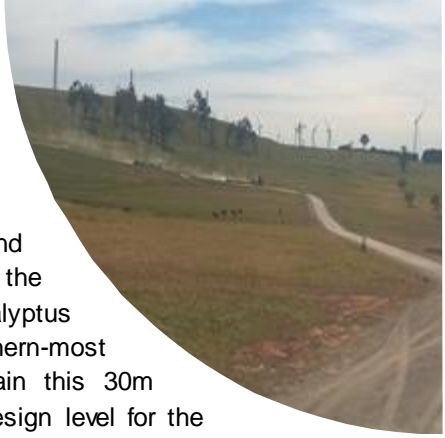
An observation was that there were two locations where there were recorded sites and there were protected with 30m buffer zones however the overall environmental outcomes of this mitigation measure was questionable.

At Turbine Row 10 a 30m buffer was fenced around the open site (OS1) from the beginning of the eucalyptus copse and the southern-most turbine (T49). To maintain this 30m buffer and provide the design level for the platform for T49 meant that a high and quite steep batter was required. This created other environmental ramifications. This could have been avoided by either modifying the mitigation strategy for OS1 or possibly, re-siting T49.

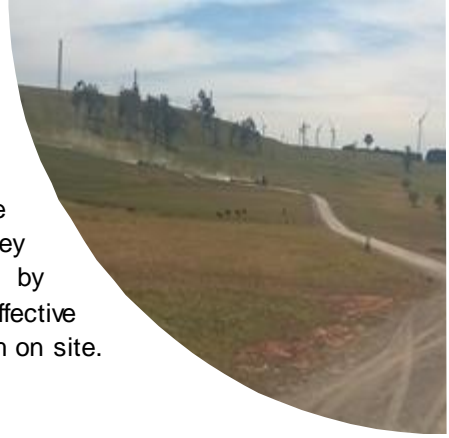
The rock check berms were observed to be at least as effective as silt fencing during rain events on site. These controls also provided a conducive environment in which to achieve grass strike and other vegetation regrowth, which reduced their visual impact, increased their filtration function and allowed full

rehabilitation of the disturbed area. They withstood the trampling by cattle and are an effective reuse of excess rock from on site.

- Integration with the other plans and tailoring to the site would have provided improved environmental measures earlier in the project.
- Controls should be suited to the nature of the site and make use of the materials available on a site.
